Thermal imaging for facade performance evaluation: informing decisions for SRG's PSU School of Business renovation

Colvin, Kelsy | North, Samuel | Griffin, Corey | Deines, Ben
Portland State University | Portland, OR | US

Overview

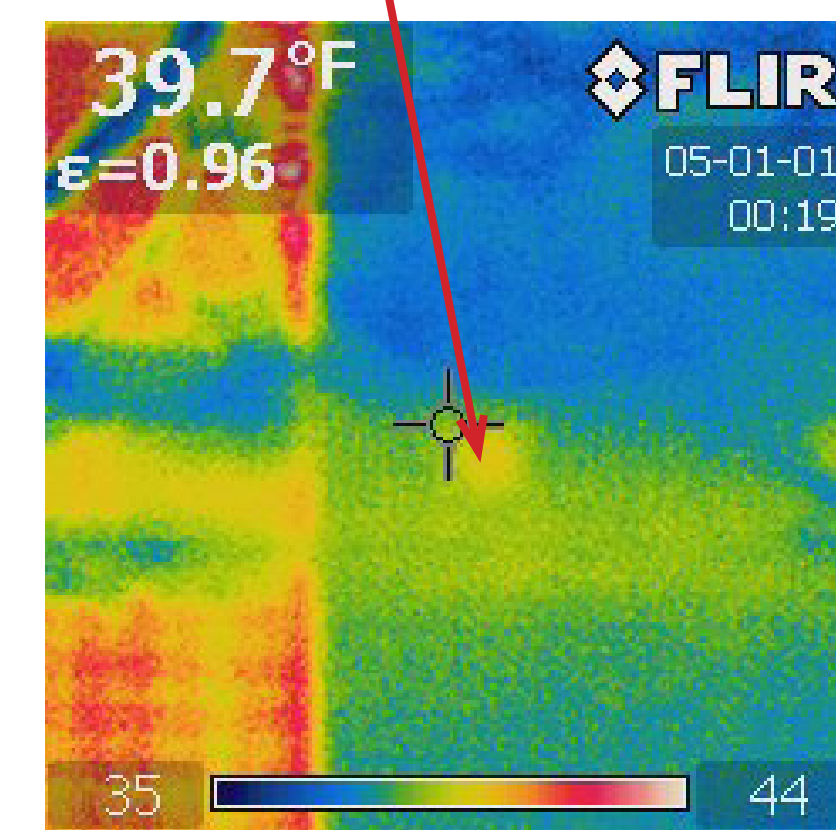
Exterior | Brick Tie

The School of Business building had a few problem areas though to a lesser degree. It also had issues with heat loss where the concrete slab floor meets the steel framing. The IR testing showed thermal bridging as well as attachment points between the brick facade and the framing.

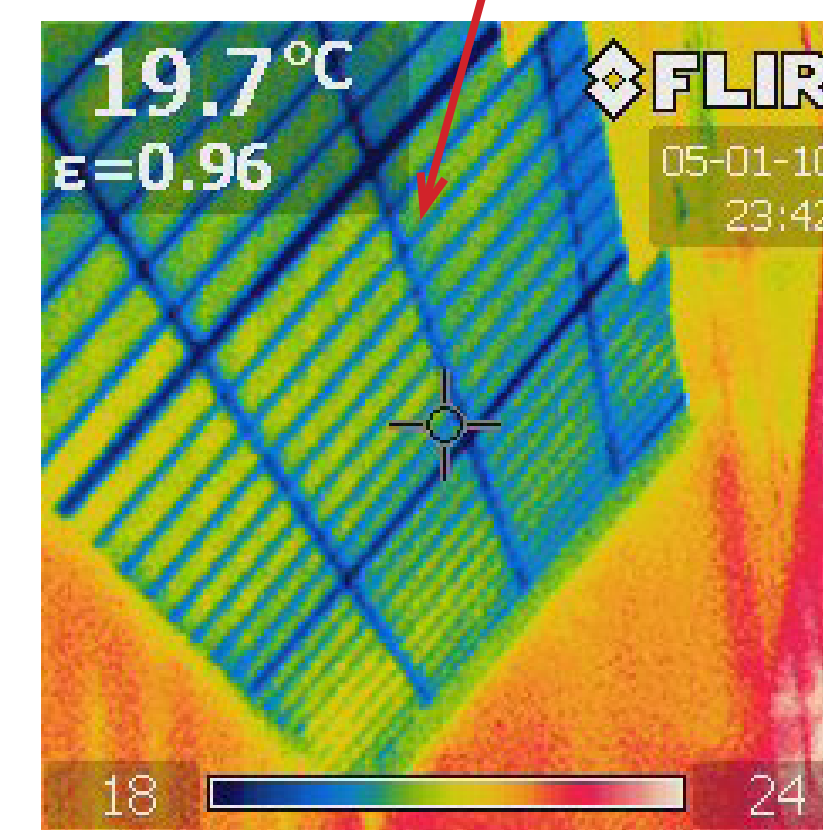
Interior | Sloped Glazing

The IR reading showed notable heat loss where the concrete slab flooring meets the exterior steel framing. It appears that this may be due to thermal bridging caused by the minimal insulation between the concrete slab and the exterior facade. There was also a great deal of heat loss through the sloped glazing on the west and north facades.

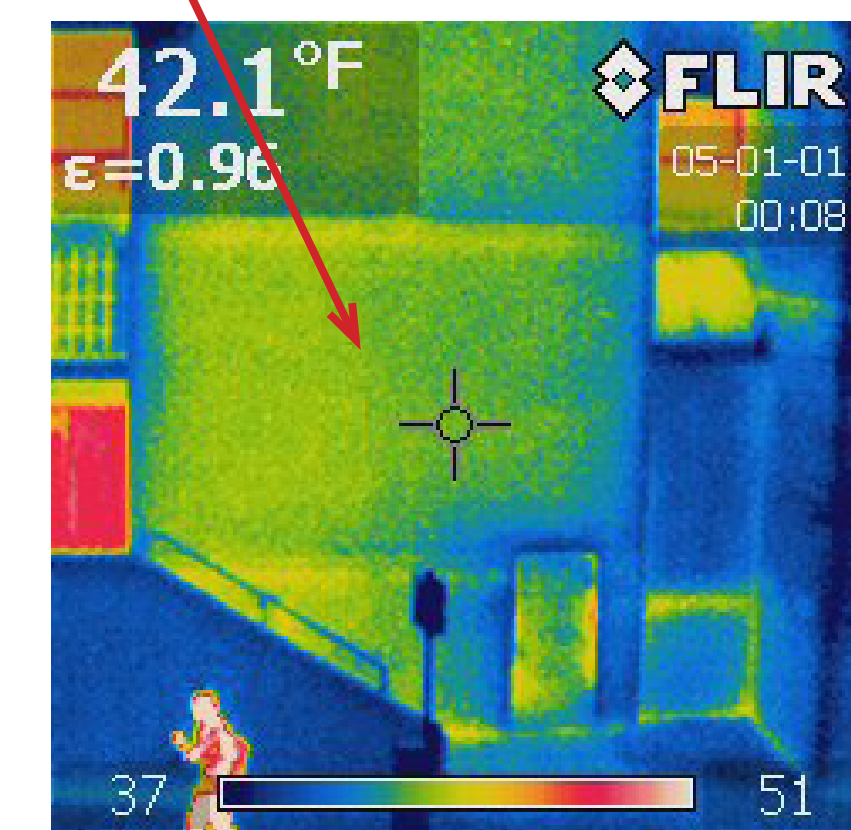
Exterior | Stairwell

The transitional space between the two buildings that hold the staircases was a problem area as it showed about 5°F greater heat loss than the rest of The School of Business and at least 2°F greater heat loss than the non-problem areas of The School of Education's facade.
