Efficacy of replacement windows in building energy retrofits: *A Post Occupancy Evaluation*

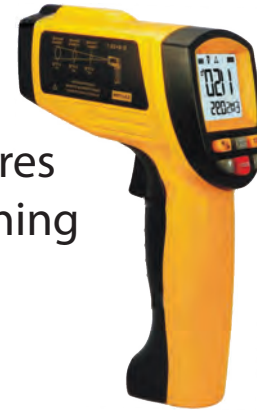
Hand-Held Temperature Gun

The Infrared Thermometer was used to compare the outside temperatures of the glazing and adjacent window frames. Temperatures were taken on the last morning of data collection, before sunrise.

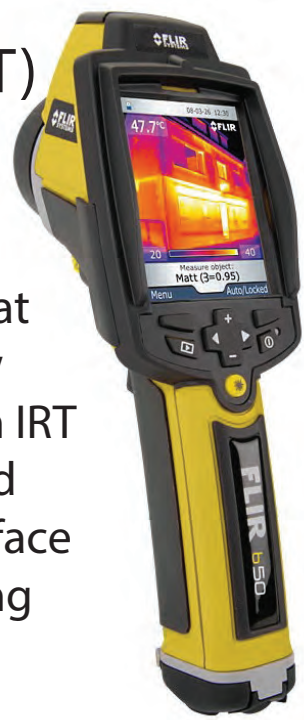
Infrared Thermography (IRT)

For a qualitative understanding of the relationship between heat loss through the window glazing vs. the frames, an IRT Camera was used to record color readings of the surface temperatures surrounding the windows. Since Infrared Thermography reads long-wave radiation being emitted from any surface, it is not effective in gauging temperatures directly from glazing, due to their high level of reflectance and light emittance.

This part of the study was purely intended to understand the amount of heat loss through the frames that could be compared with temperatures (from the data collection) showing the glazing heat loss. These photographs were taken before sunrise on the last day of data collection.

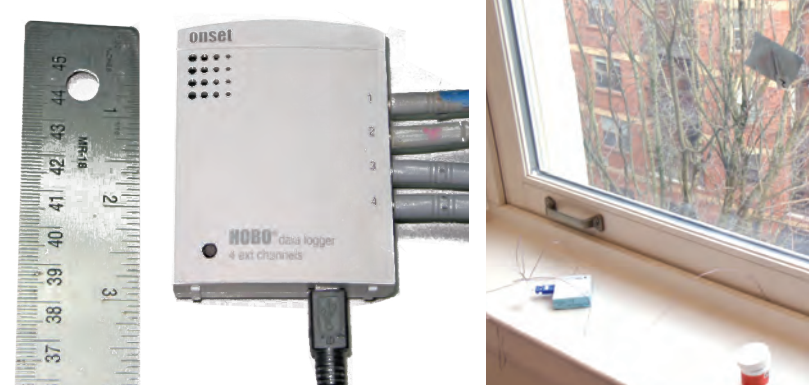
Data Collection

For a quantitative understanding of the heat loss through the window glazing, Hobo Data loggers were used to collect surface temperatures on the inside and outside of the glazing on each window. Also, indoor air temperatures were recorded, simultaneously and correlating outdoor temperatures were collected from the weather station on Shattuck Hall roof.

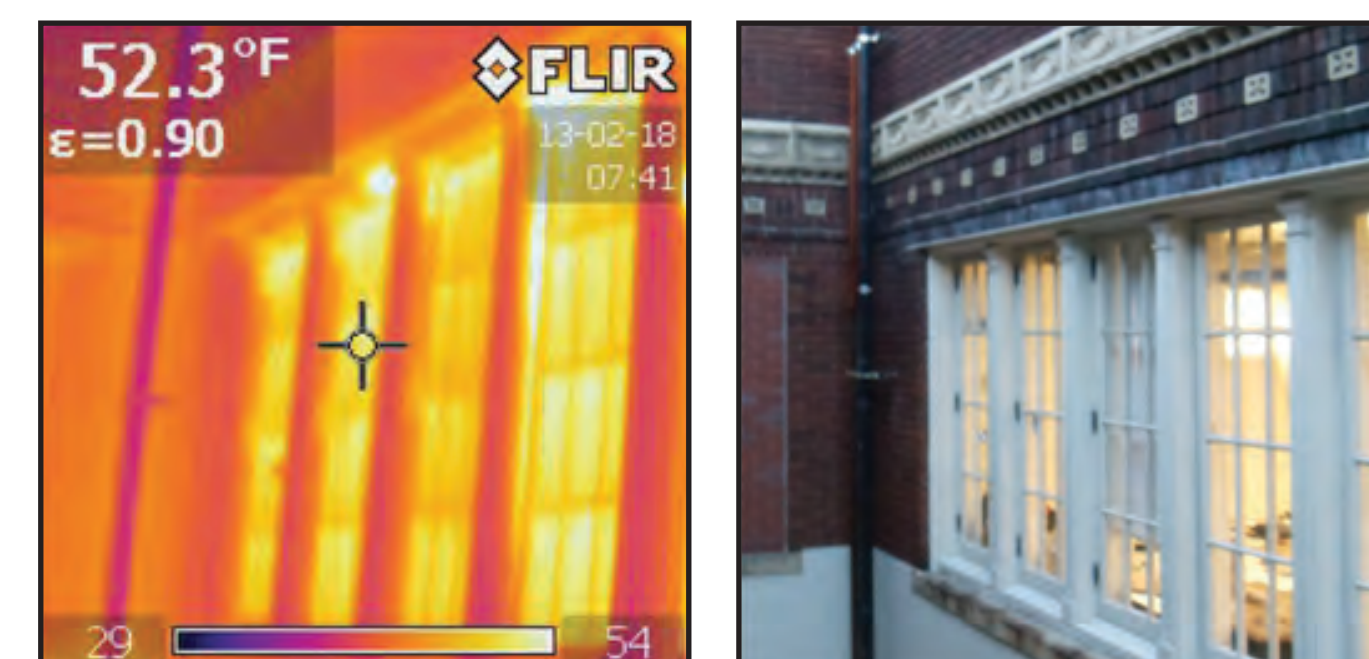
Figure 2.1 - Shattuck Hall pre-retrofit 1986. has an inefficient envelope, bridging a rate that keeps the exterior facade an average 15.5°F higher than the ambient outdoor air.

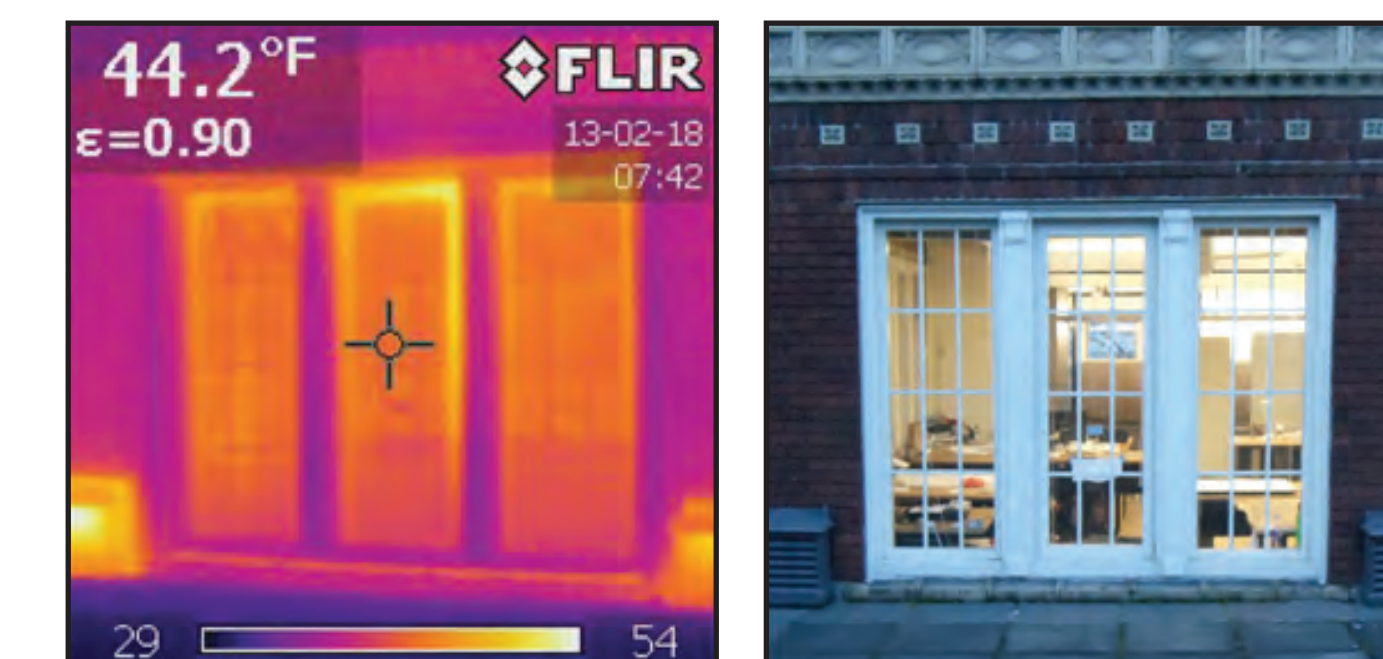
Figure 2.2 - Shattuck Hall post-retrofit 1986. has a leaky frame thermally bridging a rate that keeps the exterior facade an average 7.4°F higher than the ambient outdoor air.

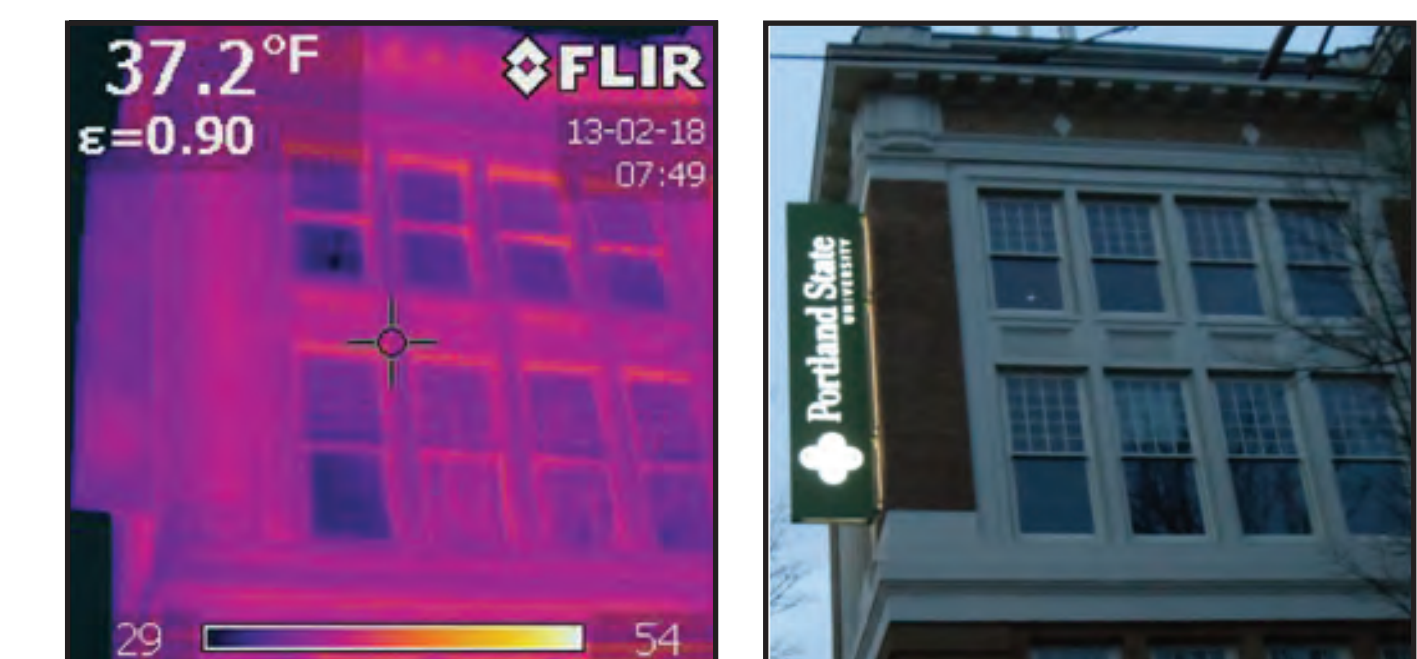
Figure 2.3 - Lincoln Hall post-retrofit 2010. has a highly efficient envelope, with a surface temperature equal to the ambient outdoor air.

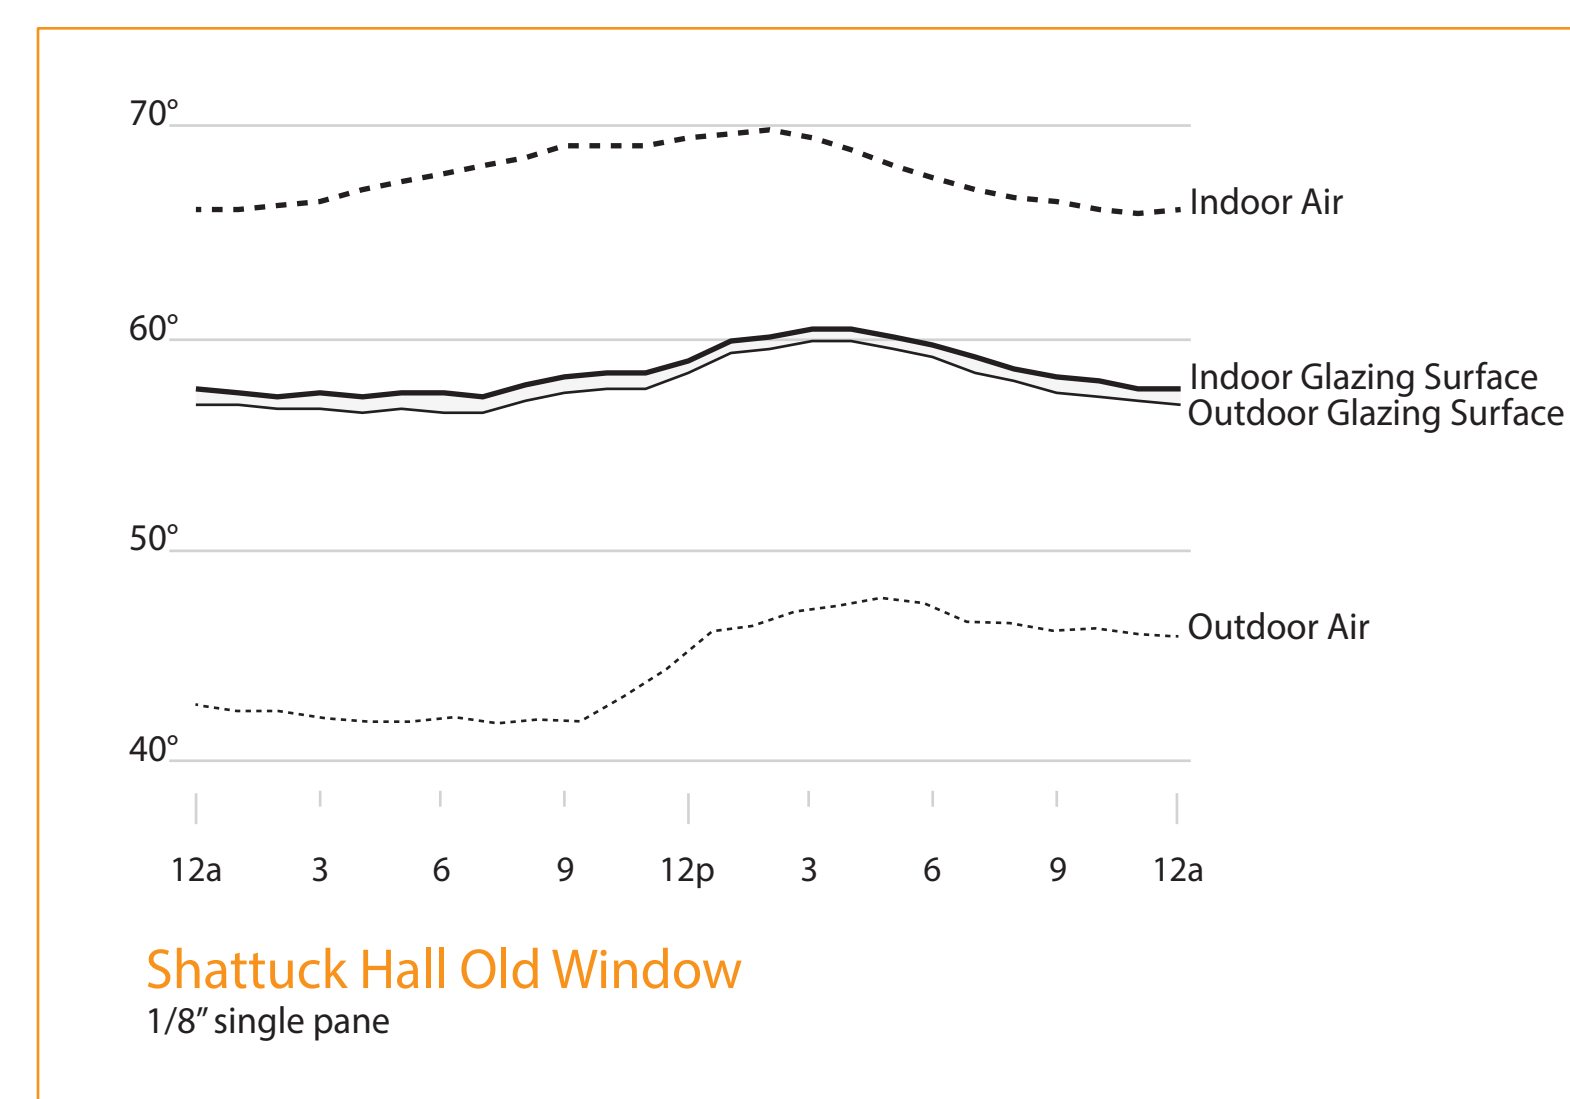
Figure 3.1 - Interior glazing surface is a mere one-degree higher than the exterior at an average of 59°F. It can be inferred that heat is escaping this glazing at a significant rate. This places considerable load on the mechanical heating and air conditioning and impacts occupant comfort near the window.

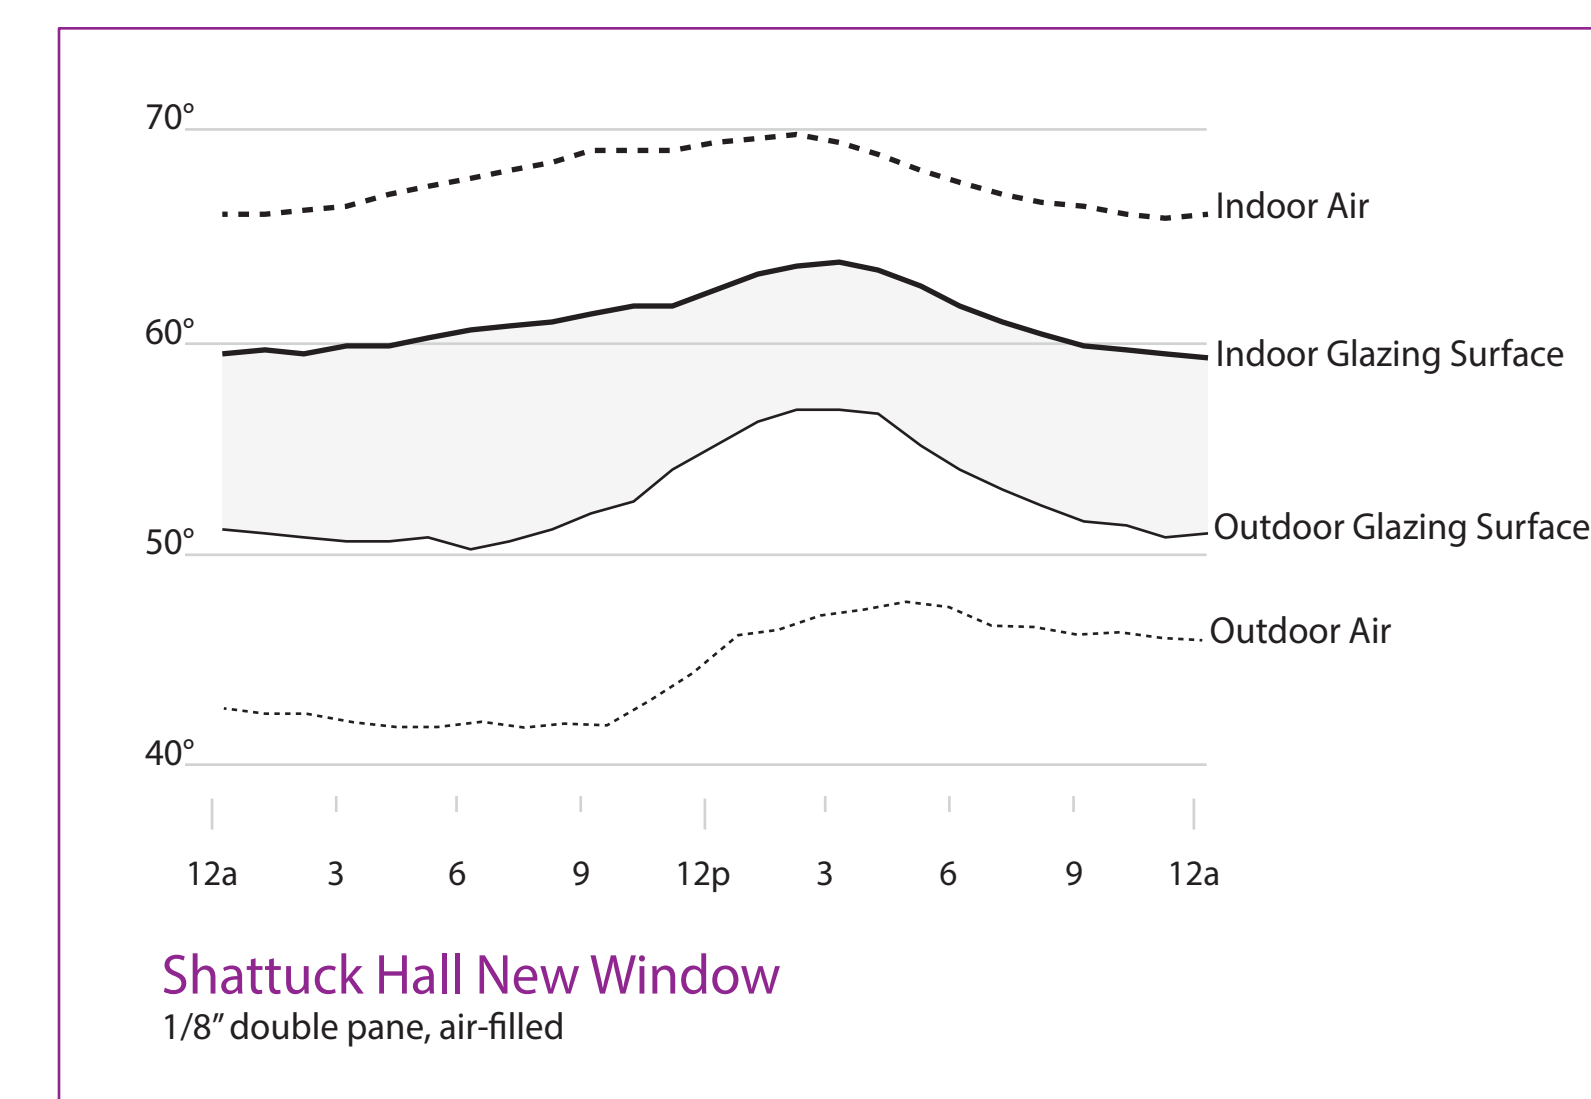
Figure 3.2 - Note an average of nine-degree difference between the interior, at average of 63°F and the exterior at an average of 54°F.

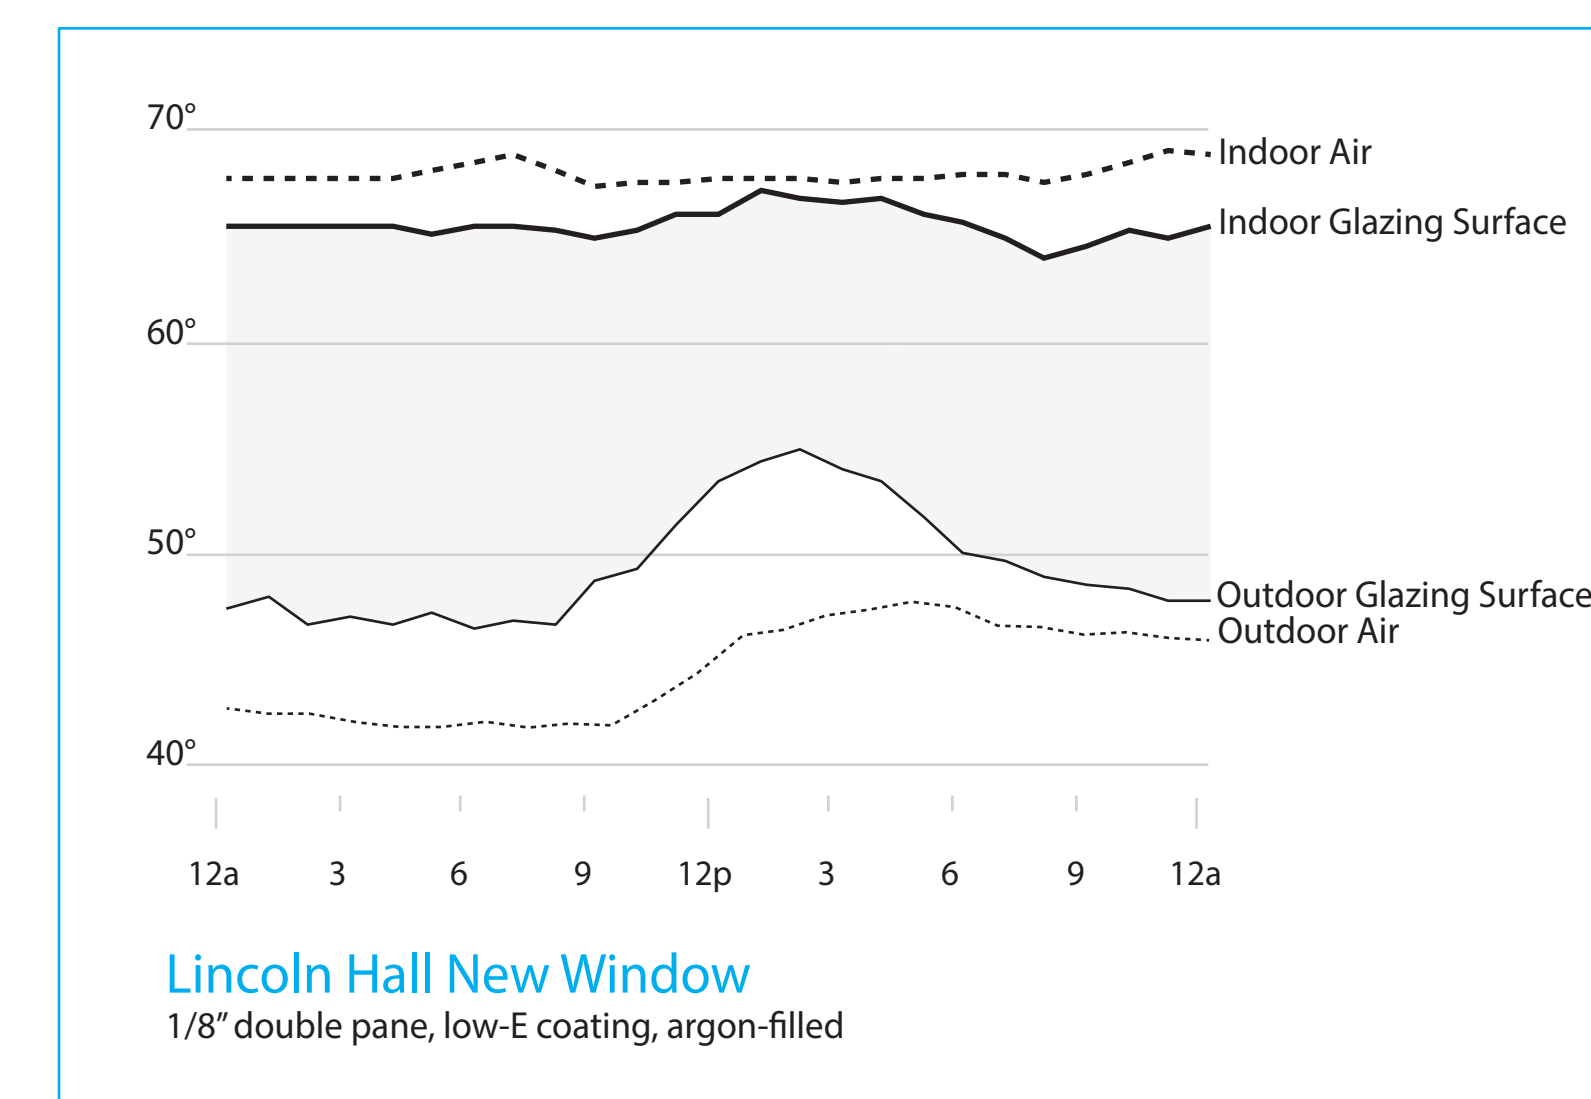
Figure 3.3 - In addition to the sixteen-degree separation from interior to exterior surface note the interior glazing temperature reaching close to indoor air temperatures, at average temperatures of 66°F and 68°F.

On the Lincoln Hall, post-retrofit graph in (Figure 3.3) in addition to the sixteen-degree separation from interior to exterior surface note the interior glazing temperature reaching close to indoor air temperatures, at average temperatures of 66°F and 68°F.

This indicates improved occupancy comfort (near the windows) and decreased heating load at Lincoln Hall.
